**STAFF REPORT
HISTORIC AND CULTURAL LANDMARKS COMMISSION
CITY OF FORT WORTH, TEXAS**

REQUEST	Certificate of Appropriateness
APPLICANT/AGENT OWNER	City of Fort Worth/ Code Compliance Annie Eliza Lewis Estate
LOCATION	5216 Turner Street
ZONING/ USE (S)	A-7.5/HC
NEIGHBORHOOD ASSOCIATION	Stop Six: Sunrise Edition

The applicant requests a Certificate of Appropriateness to demolish the main structure.

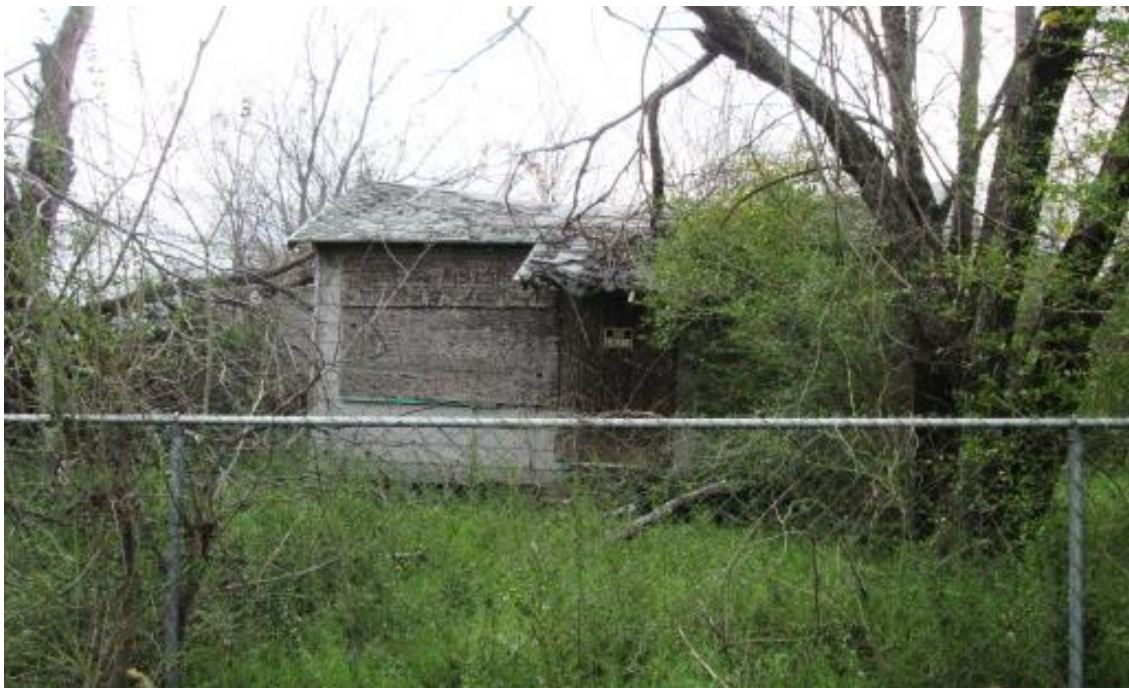
The residence is in poor condition due to deterioration and neglect. The roof is sagging heavily. The exterior walls are bowing. A portion of the rear wall and roof have collapsed. It is unknown how many original windows and doors still exist. The openings are boarded up and only some windows are visible in the rear room with the collapsed exterior wall. Preservation and Code Compliance Staff were unable to view the rest of the interior due to the deteriorated condition of the structure.

Existing North (front) Façade of Structure

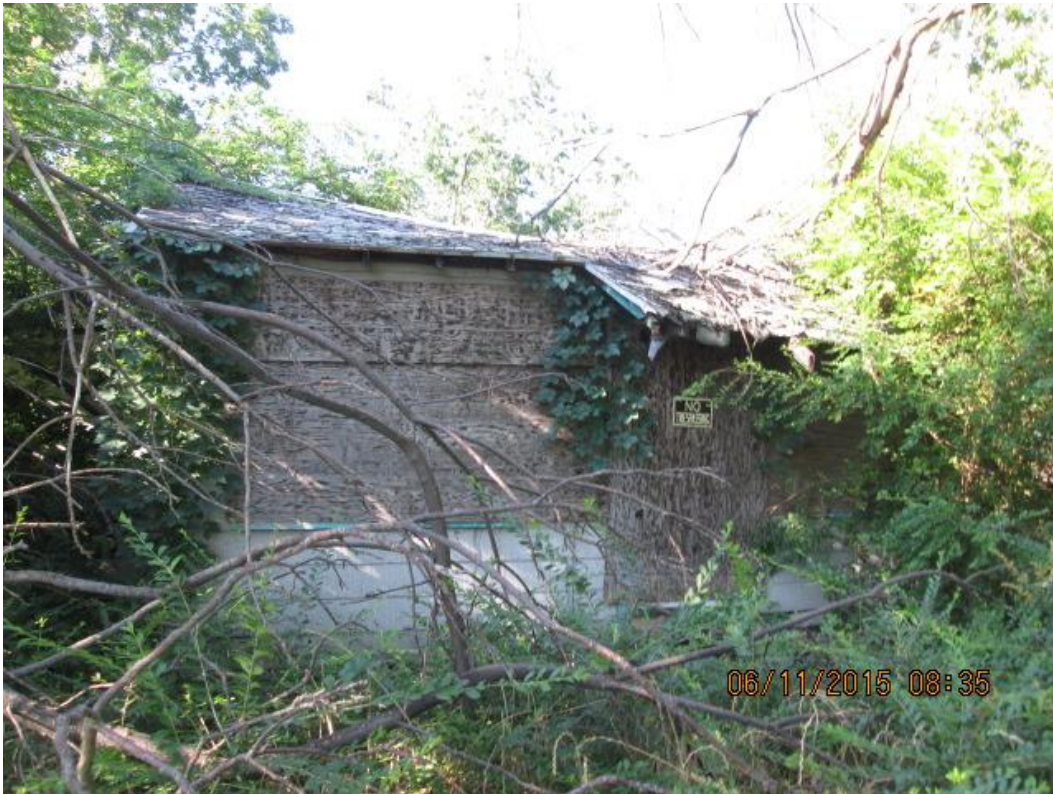
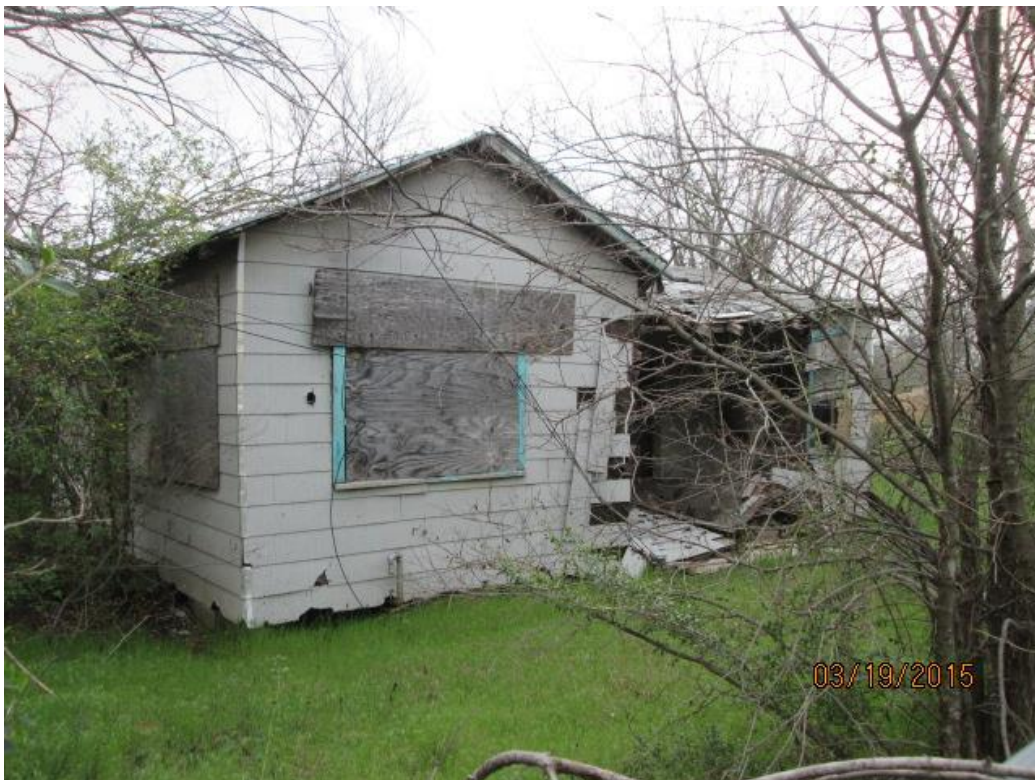
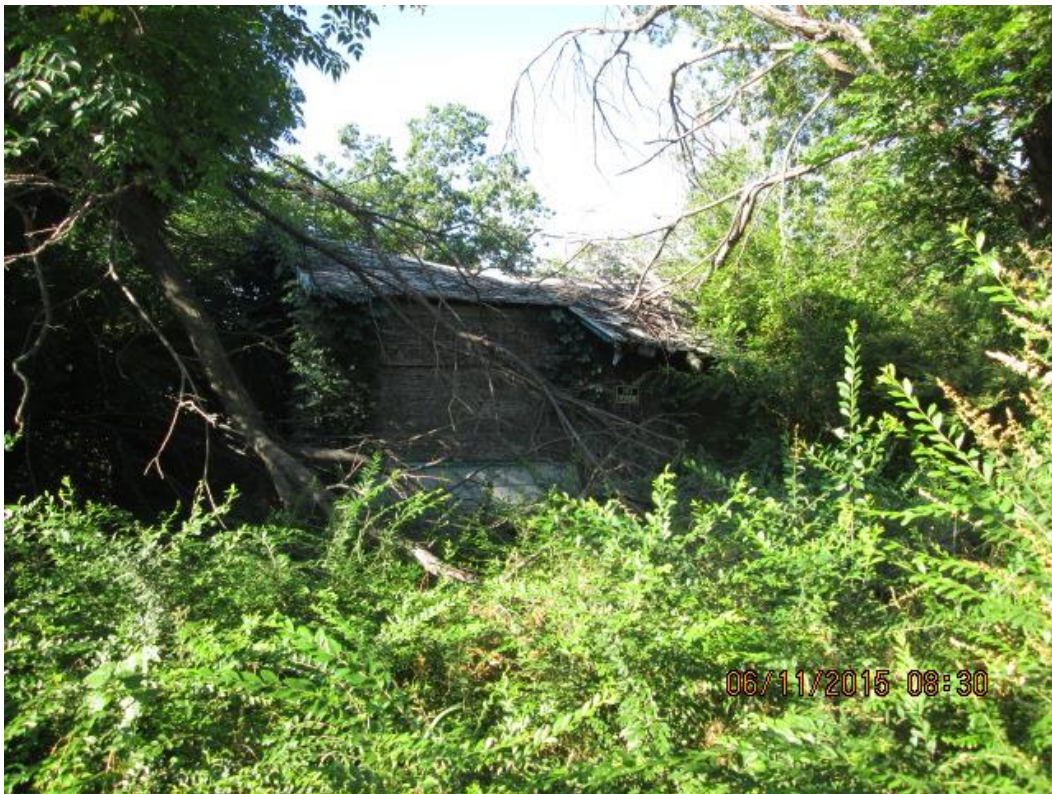
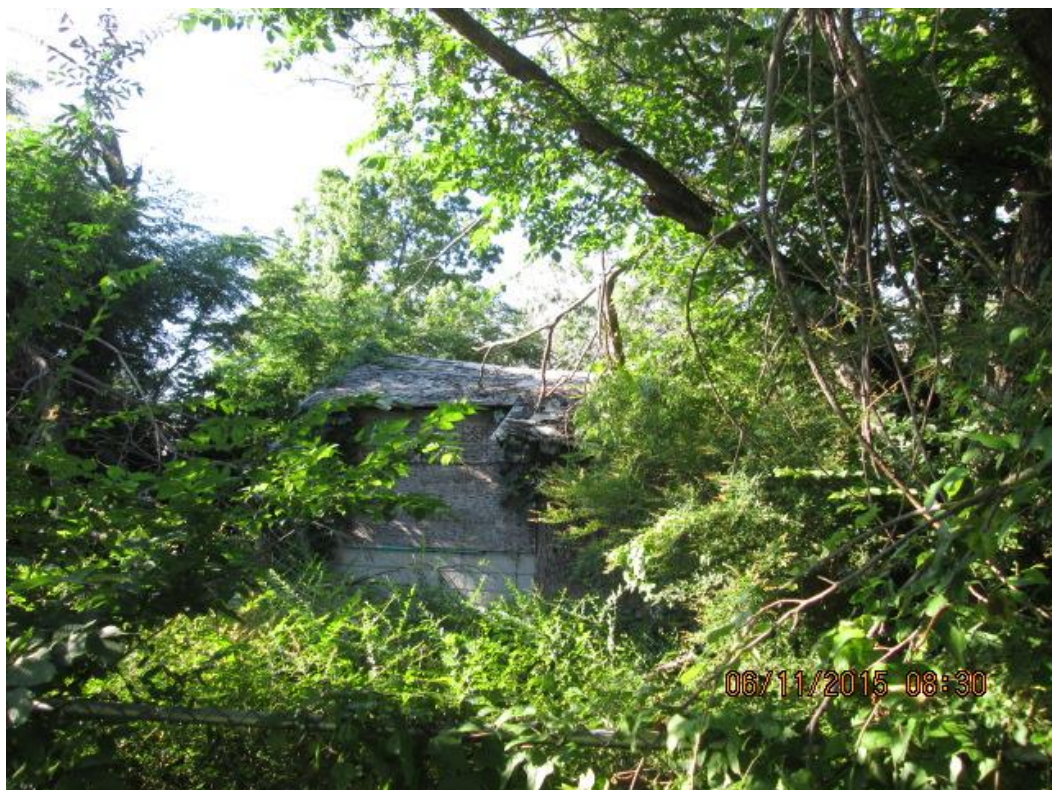
Additional Images

* Synopsis - CATI status; structure has a partially collapsed roof, ~~the~~ western side ~~area~~ wall has a portion that has completely collapsed inwards.

All construction components observed that are comprised of wood are rotten and severely deteriorated. Some are to the extent of decay that they can no longer support the structure in their respective capacity.

* Roofing shingles are missing and/or severely deteriorated and provide little to no weather protection.

* Vegetation around the property/structure is so dense that 60% of the structure is not even visible, a large tree limb has also fallen onto to roof and caused further damage.
